FINEGAN INSPECTION SERVICES, INC.
76 W. FOSTER MAINEVILLE RD.
MAINEVILLE, OHIO 45039
683-0733-PHONE 697-0163-FAX

RESIDENCE

Lot #47, Ohio

This is a **specialty construction report** as per the clients' request. The report is designed to discuss the conditions of the **foundation**, at the above address. The above mentioned conditions were observed on January 5, 2006.

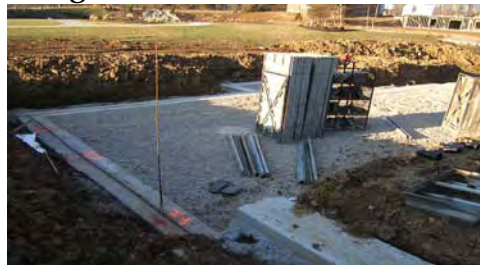
2). There was a **keyway in the footers**. This is intended to help "lock" the foundation to the footings and allow a break in the bond so that water movement is not impaired. the intersection footings would

This should insure that of the foundation and the properly seal the

footer/wall intersection.

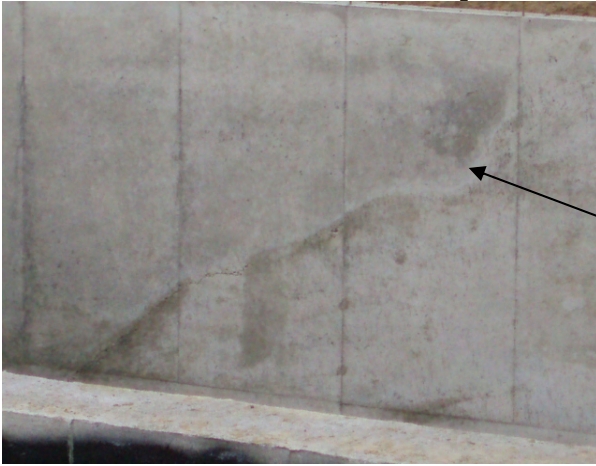
2). There was a concrete cast-in-place **foundation** installed on the site. It was noted to be plumb and appeared to be relatively square. Photo #6. With all the offsets in the foundation no calculations were attempted to determine the exact foundation conditions as in comparison to the drawings.

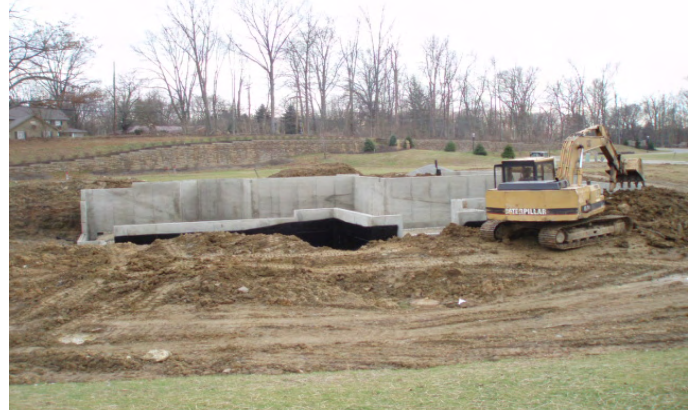
3). There were **pour lines** in the foundation, (none that would be indicative of poor quality pouring and/or concrete), but large enough to be monitored and possibly parged

over. There is no observed bowing to the foundation wall surfaces.

The only concern is that the entire foundation was poured, spray sealed and backfilled all within 72 hours. That leaves very little time for the concrete to cure. The weight of the wet clay soil against the outside of the concrete wall only could cause cracking in the foundation.

Traditionally the foundation would be backfilled **after** the concrete floor is poured and the floor is installed. In this way the foundation is properly braced off. This firm will keep a close eye on the wall system over the course of the building process.

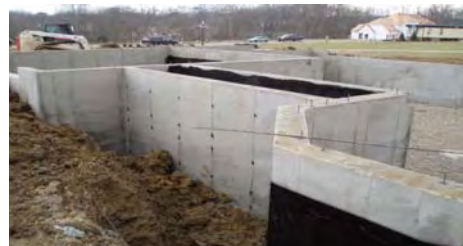
3). There was noted **spray sealant application** accomplished at the time of the inspection. The sealant is a tar-based product applied to the exterior foundation walls that are exposed to soil. The sealant, which is typical in the industry, was properly applied on all the exterior foundation wall surfaces. The sealant will not “waterproof” the foundation, but it will lower potential for leakage on the wall surfaces.

It is normal that there is no water proofing spray applied to the sub-grade front wall of the front porch. The area is filled with gravel and is not common to any living space. See photo of the spray sealant.

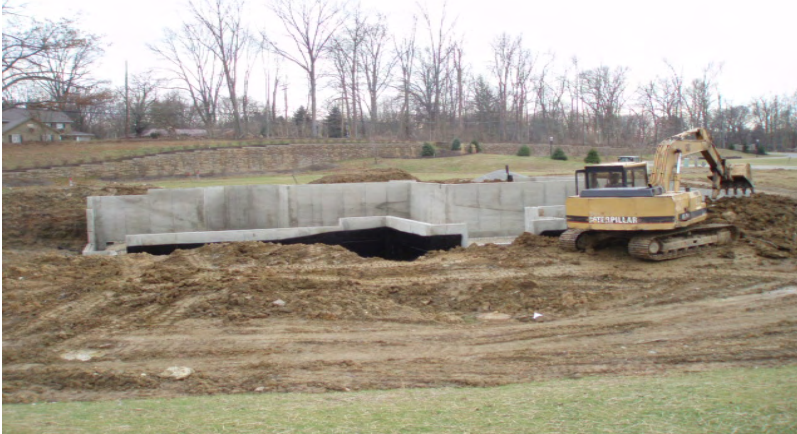
4). The **site** was noted to be without problems in terms of elevation of the foundation. There is a positive elevation of the home and all grade conditions appear to direct any future surface water away from the foundation wall surface. It was positive on all 4 sides.

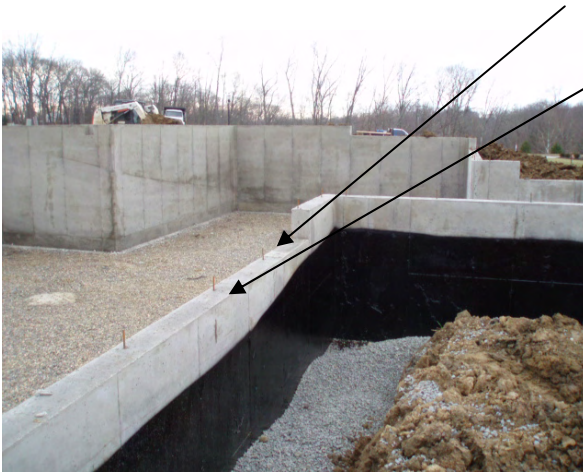
5). The foundation is set up to have **sill plate** installation with foundation bolts. This is the best way to secure the framing to the concrete surface of the foundation. As seen in photo #1, the **foundation bolts** were set up to secure the sill plate to the foundation.
